# DENSI-PROOF™

## Concrete De-Contamination

# Concrete De-Contamination continued

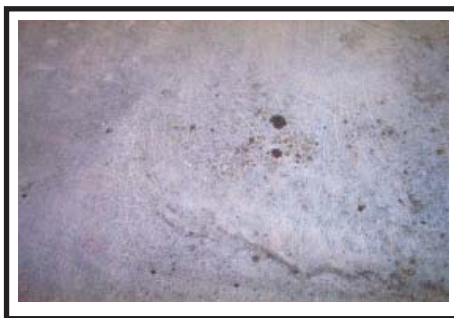
decided on because of the extent of purged material. Pressure washing, shotblasting could also have been used as cleaning/recovery methods. Immediately the residue is removed any remaining contamination is usually visible with a bleed or darkening on the surface (see below). These areas are

subsequently reapplied with Densi-Proof until either all the material is purged or encapsulated in the gel. One prolonged and heavily contaminated site in New Zealand required a few small areas to be reapplied 5 times. After cleaning off of the substrate any coating or applied covering will not be compromised from behind. The integrity of the subfloor is assured and is not a source of failure for your coating.

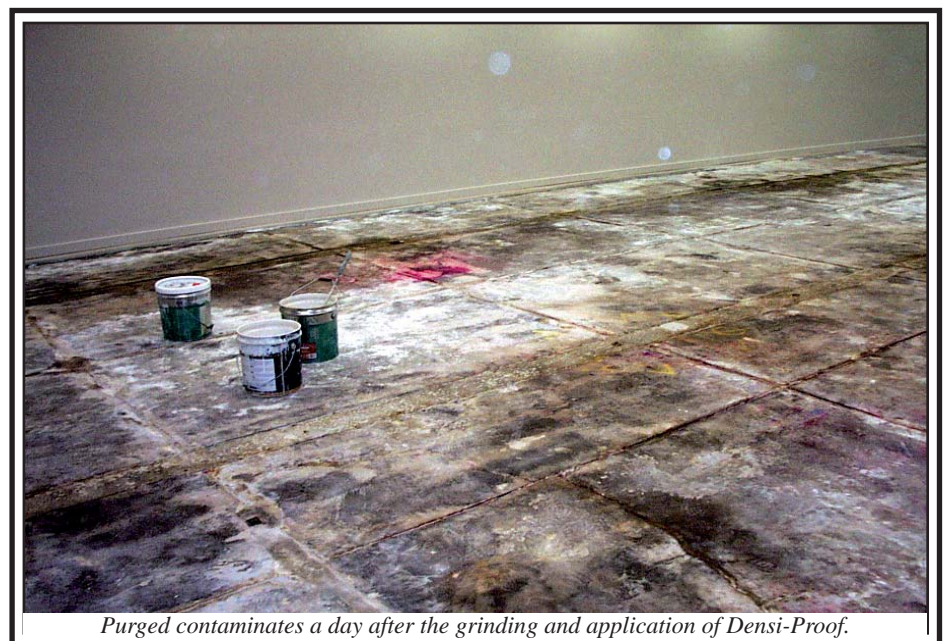
*Purged contaminants a day after the grinding and application of Densi-Proof.*

Densi-Proof is the only system that will permanently eliminate deep seated contamination and halt the effects of moisture ensuring floor coverings or coatings will not debond from the concrete substrate. The picture (bottom right) shows an old 30 plus year old engineering workshop that had oil and other contaminants dropped on to the concrete floor. The oil is a weak acid and eats away the concrete's capillaries weakening and making further contamination easier to ingress deep into the concrete's interior and do more damage. This floor was diamond ground to remove the layer of old grease and oil and expose the concrete to receive the Densi-Proof. The floor looked very clean and you would think capable of receiving a coating. We applied Densi-Proof and this is what confronted us the next morning. Years of spills and accidents, a chemical cocktail brooding and bubbling away, off gassing who knows what. The morning we entered the building there was a foul smell, obviously deep seated gases we had displaced. Diamond grinding off the contamination was

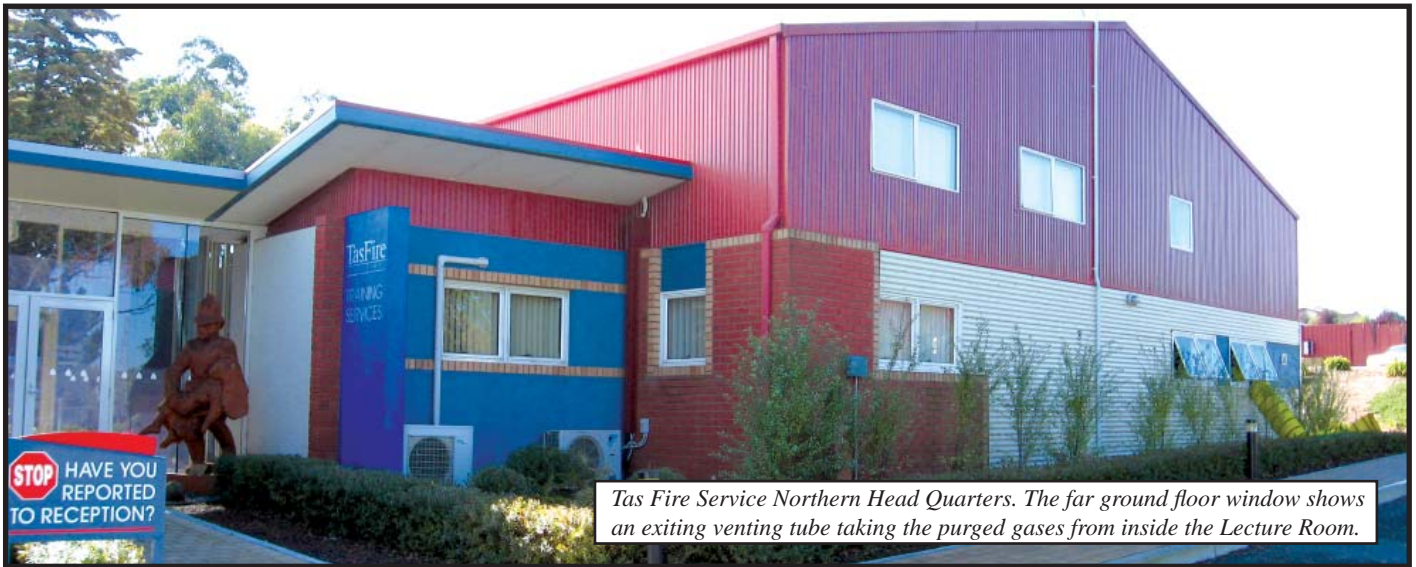
*Tas Fire Service Northern Head Quarters. The far ground floor window shows an exiting venting tube taking the purged gases from inside the Lecture Room.*

Tas Fire Service Northern Region Headquarters in Youngtown Launceston was partially built over an existing concrete slab that had been a logistic holding shed. The new Lecture/ Training room was decommissioned after some of the staff and trainees

complained of nausea and dizziness. After months of investigation the cause was put down to an old spill that was now off gassing through the concrete. Peter Allan from Dann & Allan contacted us and after a site visit we suggested a grind to remove the old adhesive and an application of Densi-Proof. The day after the first application there was some visual contamination, this was sanded and vacuumed and Densi-Proof was reapplied just to those areas. The room was kept locked and inspected daily for several weeks before a new

floor was installed and the Training room recommissioned. This was 13 months ago and no odours have been evident and more importantly no health issues.

This type of slab contamination or “sick building syndrome” can be alleviated with Densi-Proof. The gas is displaced from the voids and capillaries and will not move back through the very low molecular weight permanent gel.

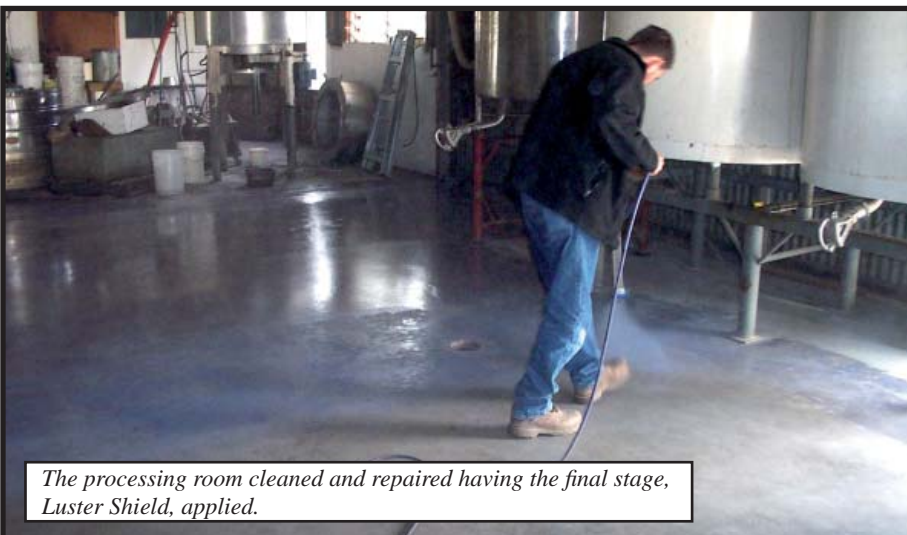
*The processing room cleaned and repaired having the final stage, Luster Shield, applied.*

Wangaratta. Bill specified Densi-Proof to stop the ravages of the acidic honey eating away at the floor, then a resurface with engineered levelling cement and a coat of Protect Crete

Luster Shield for ease of cleaning and protection from acid and chemical spills. As soon as the Densi-Proof was applied years of spilled and penetrated honey started to ooze to the surface of the concrete floor. Bill called it an unbelievable sight and joked he had to restrain the beekeeper from gathering and bottling it.

Without the option to decontaminate and remove the honey and other chemicals the modified cements or any other coating would have been tested to their limits and the likelihood of a mechanical and/or a chemical failure would have been too high to even attempt the repair. Protect Crete gave a very cost effective out come to an acid ravaged, unsafe and almost unserviceable floor.
